Improving refinery (RAM) with Compabloc plate heat exchangers

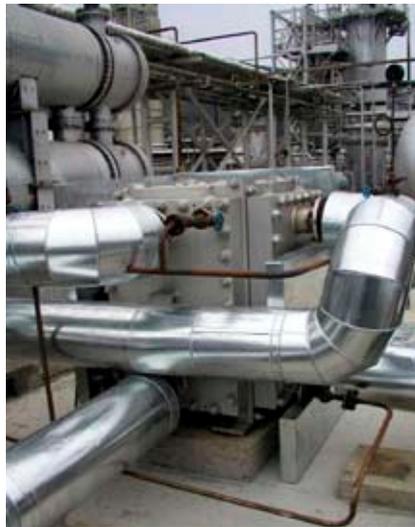
One Compabloc preheating crude since 2002 in a Russian refinery.

The country that to-date has the highest level of acceptance for CP technology is Russia. Out of 28 refineries, 27 use the technology, both to replace old shell-and-tube heat exchangers and in new process units. One of the oldest CPs in Russia is installed in a crude preheat train. It preheats crude to over 200° C using atmospheric residue as the heating media. The 170 m² stainless steel CP replaced three corroding CS shell-and-tube heat exchangers with more than 1000 m² of heat transfer surface.

Since it was commissioned in February 2002, the CP has not required any maintenance whatsoever. Due to their positive experience with this heat exchanger, the refinery has since invested in three more CPs to improve heat recovery in their crude preheat train as well as one CP that operates as a gasoline cooler in their hydrotreatment plant. The latter uses seawater as cooling media.

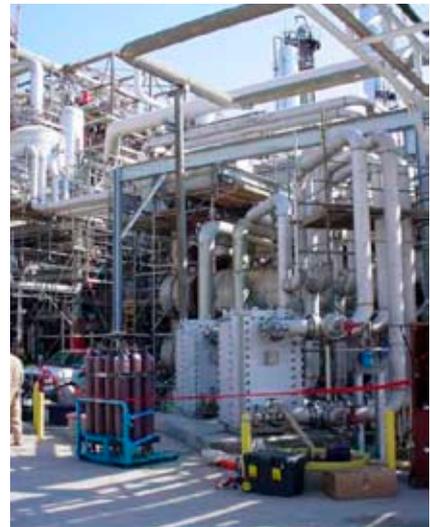
Two Compablocs preheating crude since 2004 in a North American refinery.

North American refiners have also made the leap to more modern heat transfer technologies. When one refinery wanted to expand its plant's capability to process price-advantaged crudes, new heat exchangers were needed in the crude preheat train. Due to space limitations in the plant, CP technology was chosen for the duty of preheating crude to up to 235° C using heavy vacuum gas oil (HVGO).

Because the technology was new to them, the refinery chose to install a 100% stand-by unit in parallel to

the operating CP. However, one heat exchanger alone proved to be sufficient. It operated continuously for more than 18 months without any loss of performance. The stand-by unit is used only during periods when the HVGO duty needs to be maximized. It then operates in parallel with the other CP. The refinery says that the plate technology has paid for itself many times over, and they are now considering using plate technology in their next revamping project.

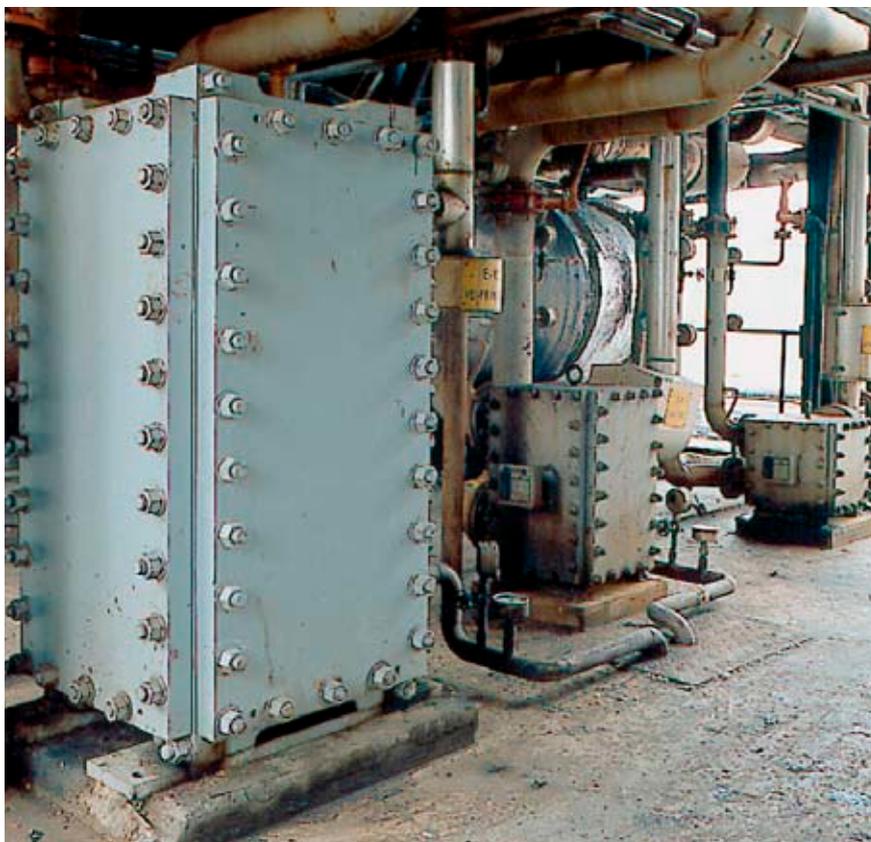
Three Compablocs operating since 1996 as ADU fraction coolers in a northern European bitumen refinery.

One of the longest operating CP installations is in a bitumen refinery in northern Europe. Here, 14 CPs are in operation, the oldest since 1996. They have all replaced low-performing, high-fouling and corroding shell-and-tube heat exchangers. The CPs are used for various duties, such as ADU fraction cooling, VDU overhead vapour condensing and bitumen heating and cooling.

The old shell-and-tube heat exchangers required cleaning and inspection yearly, an operation that took one week. The CPs, on the other hand, require chemical cleaning only every third year, and it is easily carried out in a single day. In total, for these 14 units, the refinery has reduced maintenance costs by 96%!

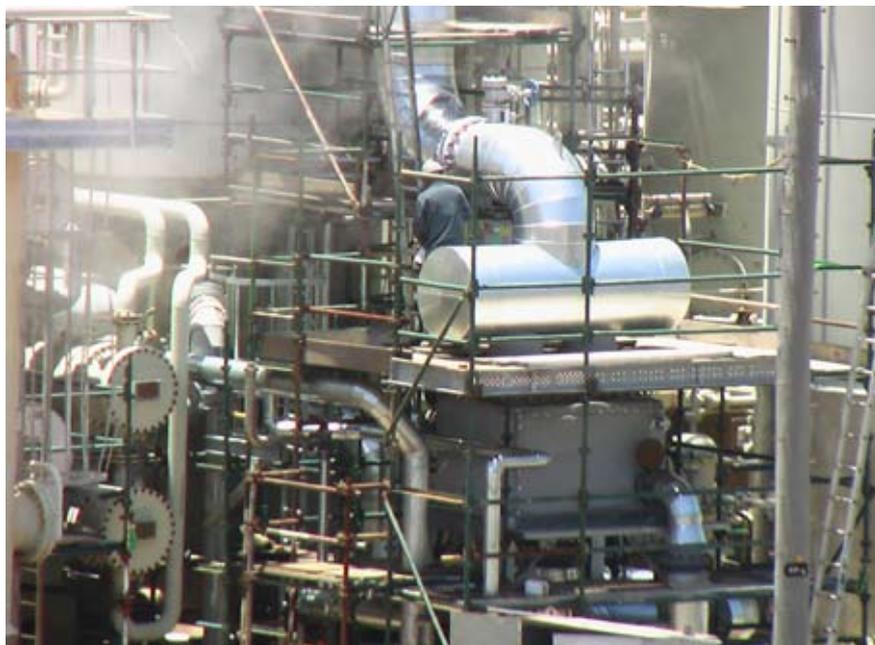
One Compabloc operating since 2006 as naphtha reboiler in an Australian refinery.

A final example proving that CPs provide both high availability and versatility, is a case from Australia. In this refinery, a CP has been operating since the beginning of 2006 as the thermosiphon reboiler in the naphtha splitter. The CP operates in parallel to and as a booster for an existing shell-and-tube reboiler. The shell-and-tube reboiler requires cleaning every six months, while the CP can operate for almost a year in between maintenance.

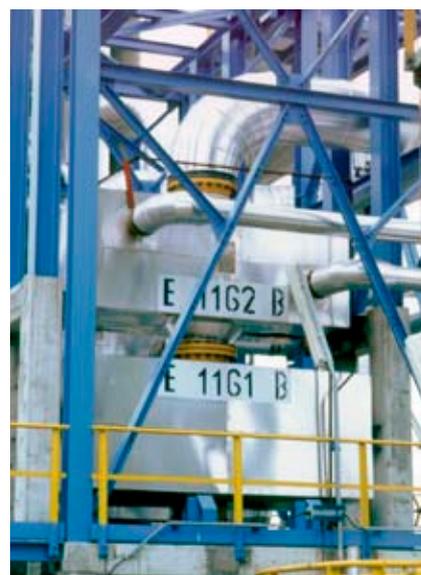
Two out of four Compablocs operating since 1997 as ADU overhead vapour condensers in a European refinery.

One installation that provides proof of both long uptime and ease-of-maintenance is in a European refinery where four titanium CPs are used for maximum heat recovery from the ADU overhead vapours.

Both crude and boiler-feed-water is preheated by means of two CPs operating in series. The two parallel lines are installed high above ground, next to the distillation tower.

The first cleaning took place in 2002 after five years of operation. The cold circuits, crude and boiler-feed water, did not require any cleaning, while the vapour circuit was cleaned, mainly to remove salt crystals formed in the heat transfer channels.

Chemical cleaning alone was used to restore the performance. First, hydrocarbon-related fouling was removed by circulating a heated caustic solution. Then, after rinsing, salts such as iron sulfide, were removed using a sulfamic acid cleaning agent. Finally, the CS

pipings was neutralized and passivated by circulating a sodium carbonate solution through the CP. Before the heat exchanger was put back into operation, it was rinsed with demineralized water. The entire cleaning procedure took around three days.

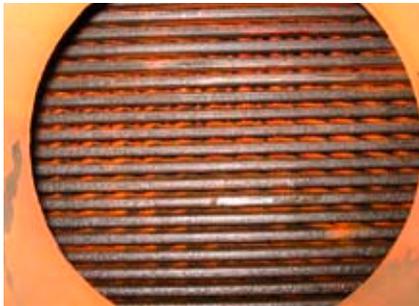
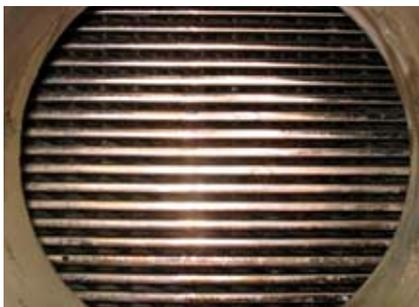
Endoscopic photo of hot stripped water circuit taken from the inlet nozzle of a Compabloc operating since 2003 as interchanger in a SWS unit in a South America refinery. Photo shows before and after chemical cleaning.

Another example of successful chemical cleaning comes from a South American refinery. Here the CP operates as an interchanger between sour and stripped water in the SWS process. Due to the acidity of the sour water, the carbon-steel stripping tower suffers from corrosion problems, and iron oxides and sulfides enter the hot circuit of the CP with the stripped water. The heat exchanger must be chemically cleaned frequently to restore its performance.

First, the CP is flushed with hot water, and then a weak, heated caustic soda solution is circulated through its channels. After a second flushing with water, a weak, heated phosphoric acid solution is used. Finally, before the heat exchanger is put back into operation, it is flushed a third time with hot water.

The cleaning procedure takes around one shift, and the result is verified by means of endoscope photos of the heat transfer channels taken from the connection nozzles.

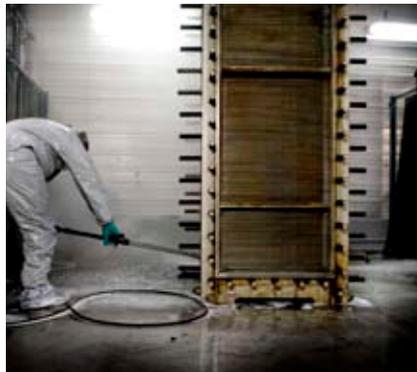
This means the hydro-jet passes through the heat exchanger when the nozzle is tilted in 45 degree angle.

Because the plate pattern is specifically made at a 45-degree angle, unrestricted channels are formed in this direction. Furthermore, the non-corrugated, flat channels at the edges of the plates efficiently drain the foulant out of the heat exchanger. By tilting the high-pressure water lance at a 45-degree angle, the entire plate area can be accessed if the plate pack is cleaned first from the front and then from the back.

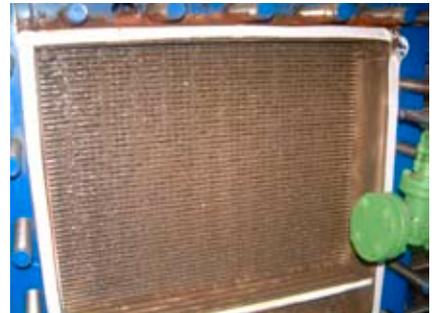
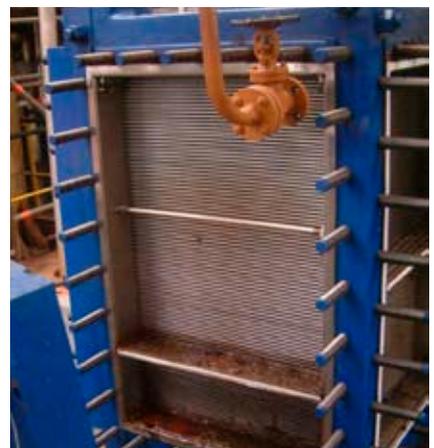
Photo showing before and after high-pressure water-jet cleaning of the cooling water circuit of a Compabloc operating as condenser in the solvent recovery part of a paraffin removal plant in Europe.

In a European lube oil plant, a CP has been in operation since 2004 as a condenser in the solvent recovery part of the paraffin removal plant. It needs regular cleaning every 12-15 months due to calcium-carbonate scaling on the cooling-water side. It is cleaned with high-pressure water of 800 – 1000 bars, using heated water and either rotating nozzles or nozzles with narrow spraying angles. The cleaning procedure, which includes opening, cleaning, closing and tight-testing, takes eight hours and can be carried out during one shift.

The CP replaced three carbon-steel shell-and-tube heat exchangers that had problems with corrosion. The same cleaning procedure (including opening, cleaning, closing and tight-testing) for those heat exchangers took 2-3 days.

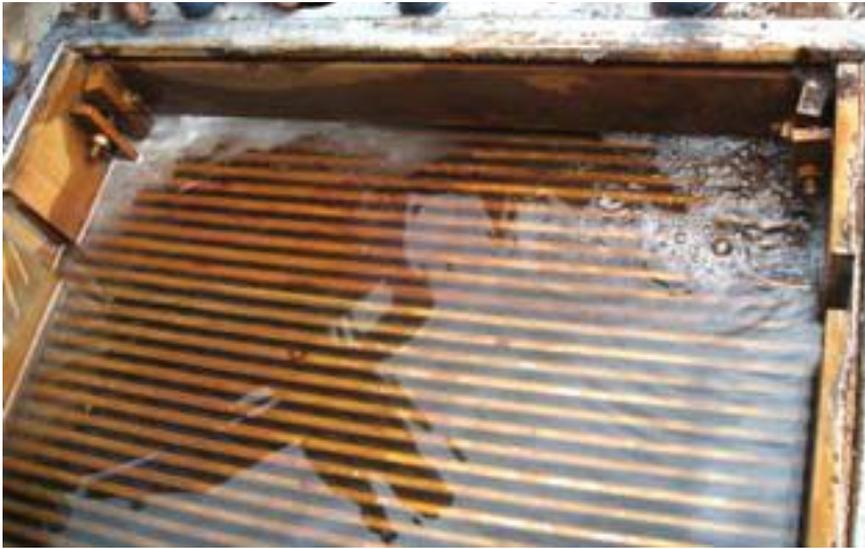
Photo showing a leaking corner weld of a Compabloc being air-bubble tested.

As the CPs are small and their frame panels can be removed, the easiest way to identify and localize a leak is to do an air-bubble test. The CP is placed horizontally on the floor, with the top panel removed and that circuit is filled with water. When air is blown through the other circuit, the resulting bubbles will quickly reveal the location of the leak. This area can now be dye-penetrant tested to further narrow the exact location of the leak.

A corner or column weld leak is the most common type of failure because these welds are subject to the strongest mechanical forces. This is especially true for CPs operating in batch-processes with frequent shutdowns and start-ups or in unstable processes with high-amplitude pressure variations or high-frequency vibrations. These leaks are uncommon in CPs installed in continuous and stable refinery processes and are known to have occurred in less than 2% of all installations.

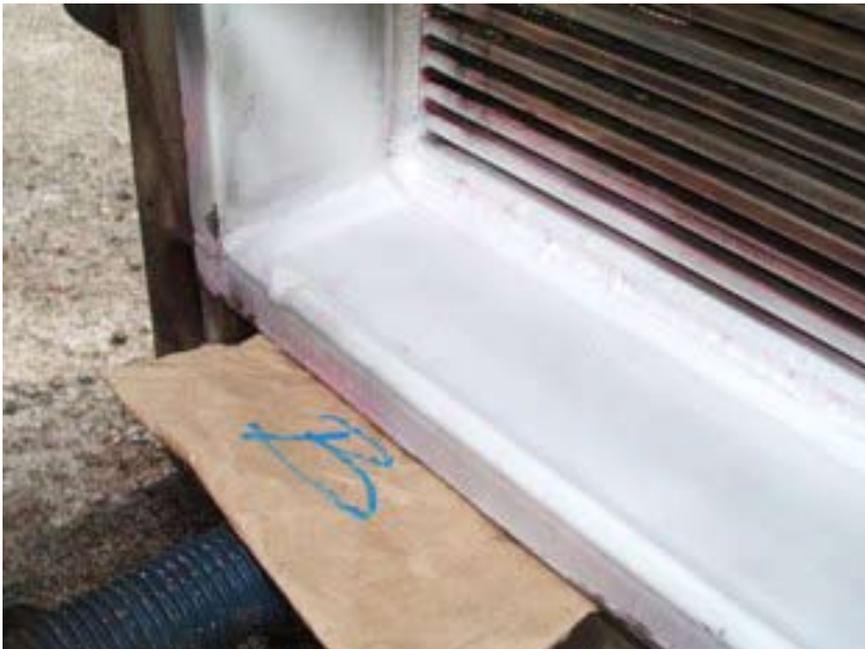
Here the result of the dye-penetrant test after a corner weld has been TIG repaired.

Repairing the CP is facilitated as all welds are external and accessible once the panels are removed. Manual TIG welding is used to repair all types of leaks. To avoid oxidation, the welding must be done with argon gas shielding.

After a weld has been repaired, its quality is tested using any or several of the following methods: air-bubble test, dye-penetrant test, hydrostatic-pressure test or helium-leak test. However, before any repair work can begin, the leak has to be identified and localized.

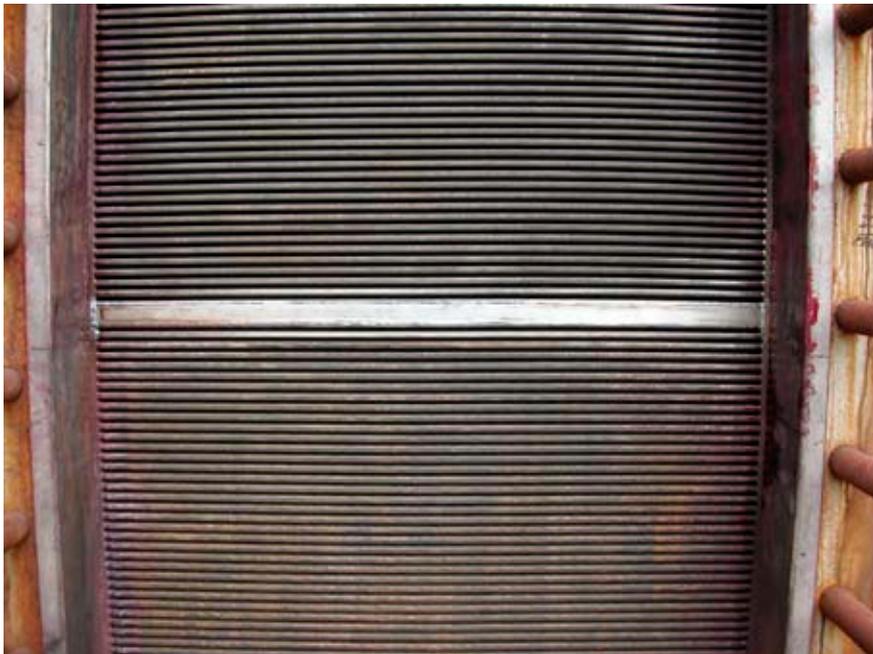
Photo showing a cross-leaking Compabloc channel sealed with a metal-strip.

However, in the rare instance that a hole does develop in a heat transfer plate, the CP can be repaired in exactly the same way as a shell-and-tube heat exchanger with a cross-leakage: by sealing off the damaged channel.

In a shell-and-tube heat exchanger, it is easy to seal off such a channel by plugging the tube with a rubber plug. Sealing off a CP channel requires manual TIG welding of a metal strip to cover the entire plate channel.
